# Manhole Inspection Summary

Manhole # S31O\_\_011MH

Insp Date: **9/16/08 2:04 PM**

**Location** Address: **oriole parking lot c.6**

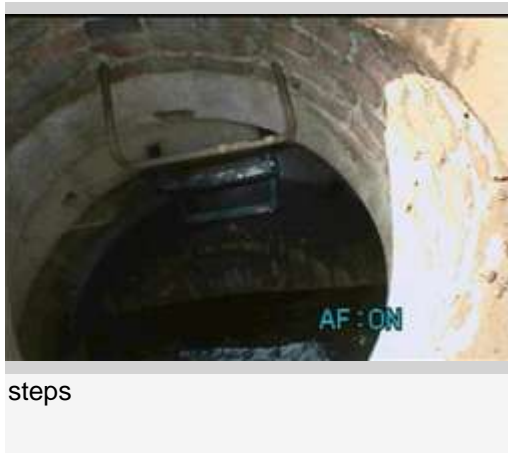
Miscellaneous

steps

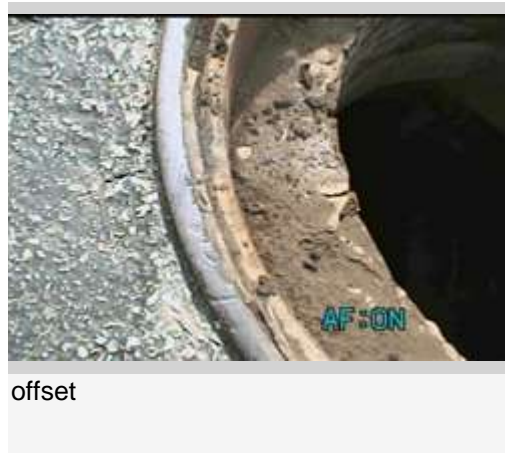
Defect 1

**Frame** Offset: **6** (in.) Condition: ☒ Sound ☐ Cracked ☐ Leaks

offset

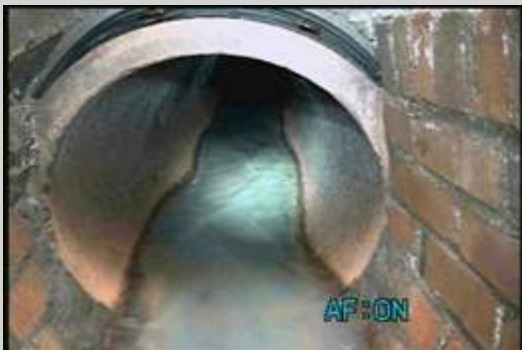
12 O'Clock Outflow

18 in. Circular Gravity Sewer  
Pipe Out @ 12 O'Clock

Invert Depth: **6.80** (ft.) Flow Characteristics: **Fast**

Infiltration: **None** Pipe Seal Cond: **Unknown**

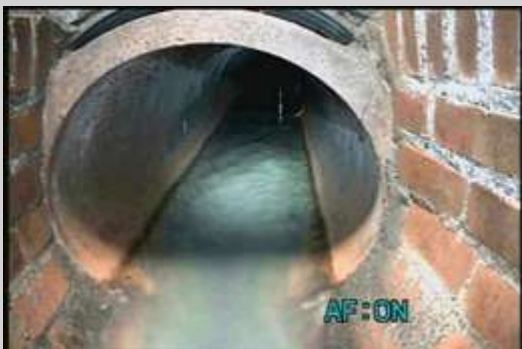
6 O'Clock Inflow

18 in. Circular Gravity Sewer  
Pipe In @ 6 O'Clock

Invert Depth: **6.67** (ft.) Flow Characteristics: **Fast**

Infiltration: **None** Pipe Seal Cond: **Unknown**
